Manhole Inspection Summary

Manhole # S13C__026MH

Insp Date: **1/28/08 1:39 PM**

Location Address: **516 POPLAR GROVE ST**

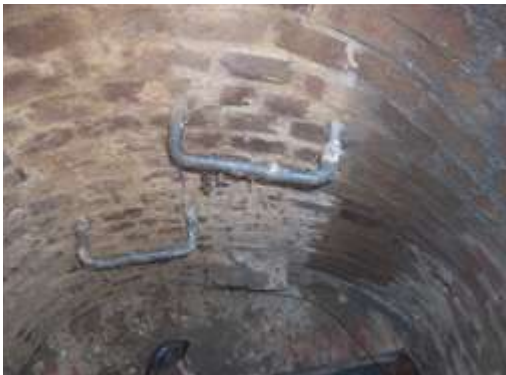
bottom step is a brick

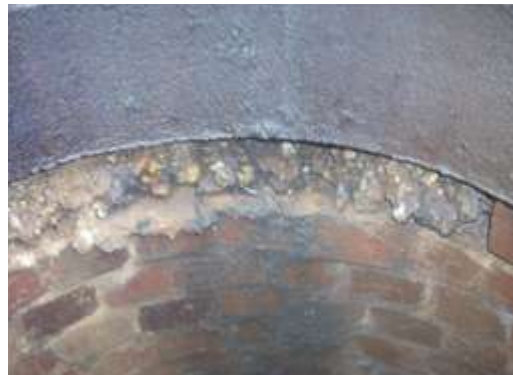
Defect 1

Condition: ☐ Sound ☐ Cracked ☐ Root Intrusion ☐ Loose Brick ☒ **Deteriorated**

Infiltration: ☐ None ☒ **Joint** ☐ Cracks ☐ Mortar ☐ Roots ☐ Wall

INFILTRATION EVIDENCE AND
DETERIORATED ON CHIMNEY

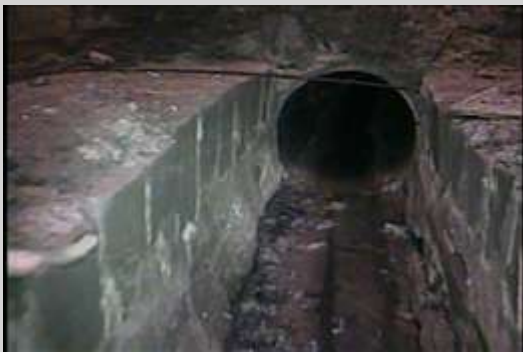
12 O'Clock Outflow

8 in. Circular Gravity Sewer
Pipe Out @ 12 O'Clock

Pipe Height: **8.4** (in.) Rod and Bar (Angled)
Pipe Material: **Clay** ☐ Pipe Lined
Invert Depth: **7.07** (ft.) Flow Characteristics: **Slow**
Deposits: ☒ None ☐ Mud ☐ Sludge ☐ Debris ☐ Grease
Silt Depth: (in.) Deposits Extent:
Infiltration: **None** Pipe Seal Cond: **Sound**

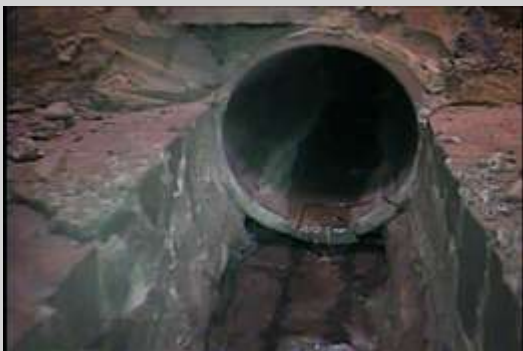
6 O'Clock Inflow

8 in. Circular Gravity Sewer
Pipe In @ 6 O'Clock

Pipe Height: **8.4** (in.) Rod and Bar (Angled)
Pipe Material: **Clay** ☐ Pipe Lined
Invert Depth: **6.82** (ft.) Flow Characteristics: **Slow**
Deposits: ☒ None ☐ Mud ☐ Sludge ☐ Debris ☐ Grease
Silt Depth: (in.) Deposits Extent:
Infiltration: **None** Pipe Seal Cond: **Sound**
